# DATA AND PRELIMINARY CONDITIONS ANALYSIS REPRESENTING A “BLIGHTED AREA”

## **TROOST – EMANUEL CLEAVER II STUDY AREAS**

KANSAS CITY, MISSOURI

October 28, 2013

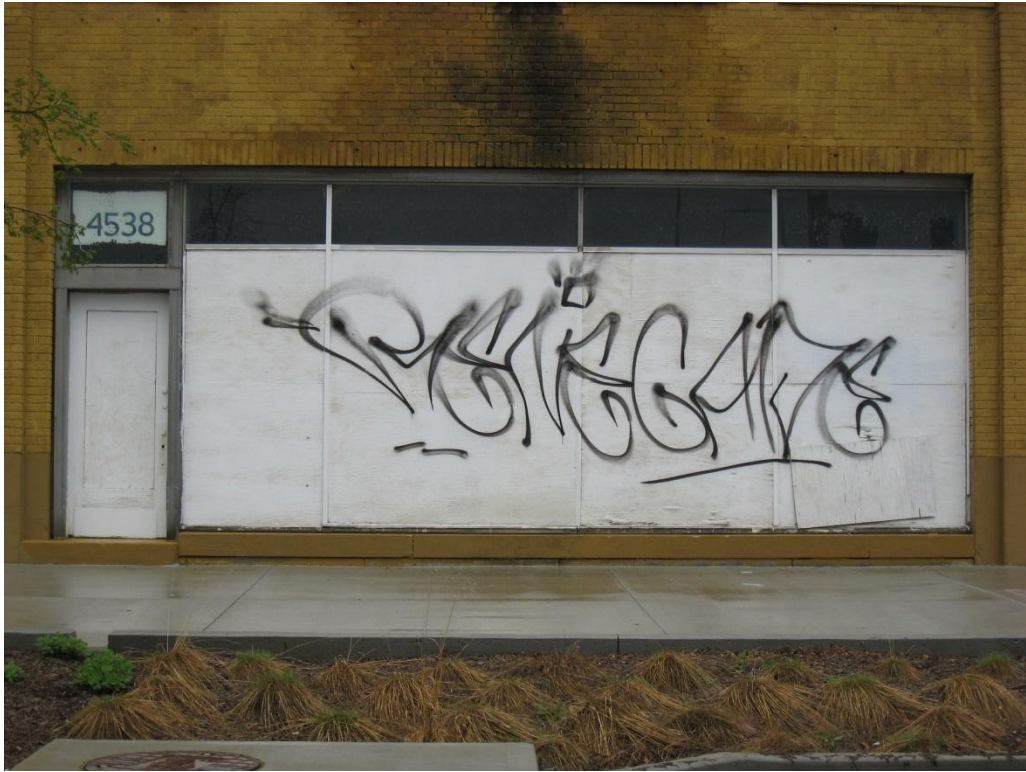
Deteriorated exterior wall conditions and graffiti at 4538 Troost Avenue  
*(Deteriorated or inadequate site improvements, Menace to public health, safety)*

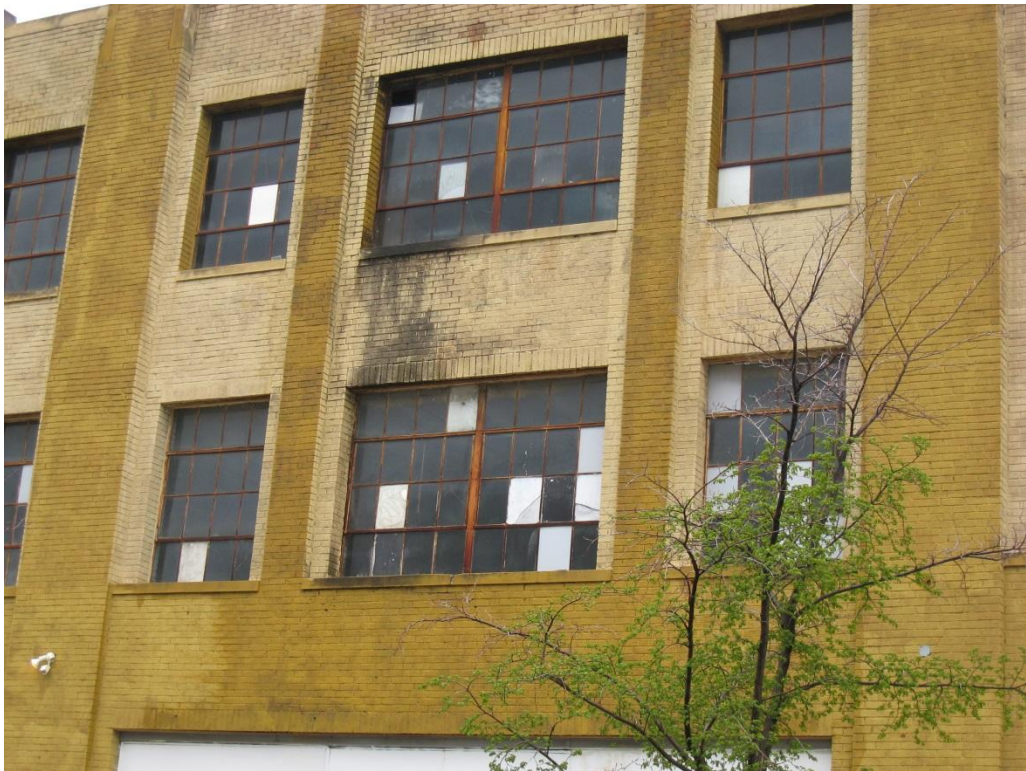
Deteriorated exterior walls, windows and paint at 4538 Troost Avenue  
*(Deteriorated or inadequate site improvements)*

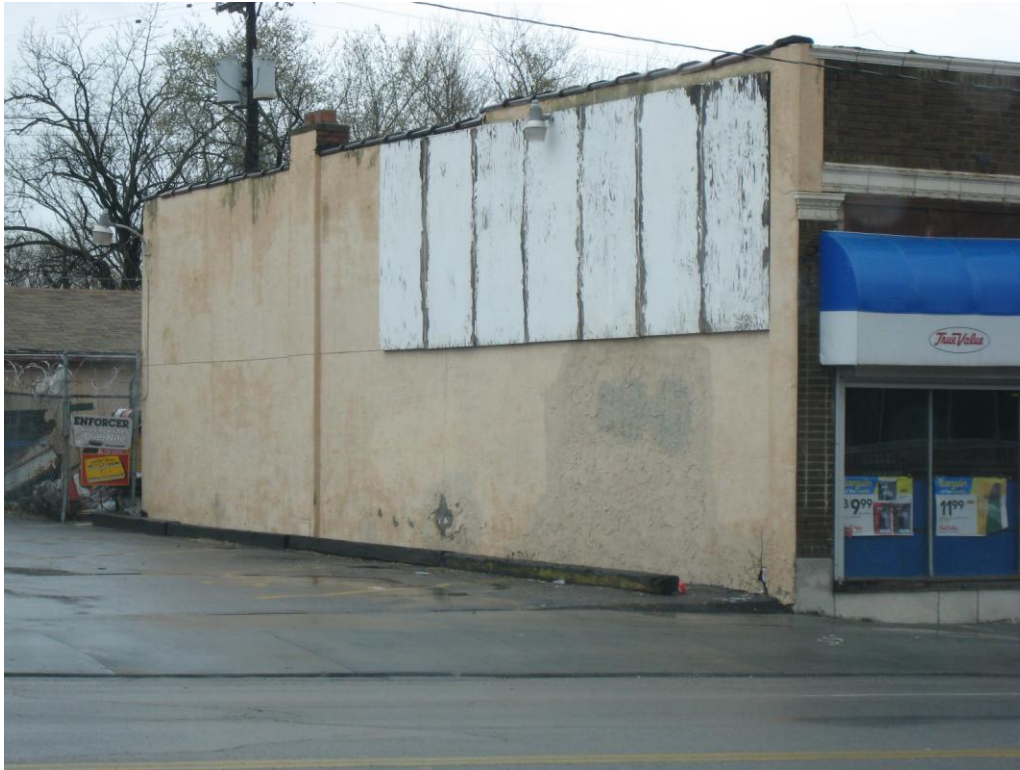
Deteriorated exterior walls and paint on north side of 4627 Troost Avenue  
*(Deteriorated or inadequate site improvements)*

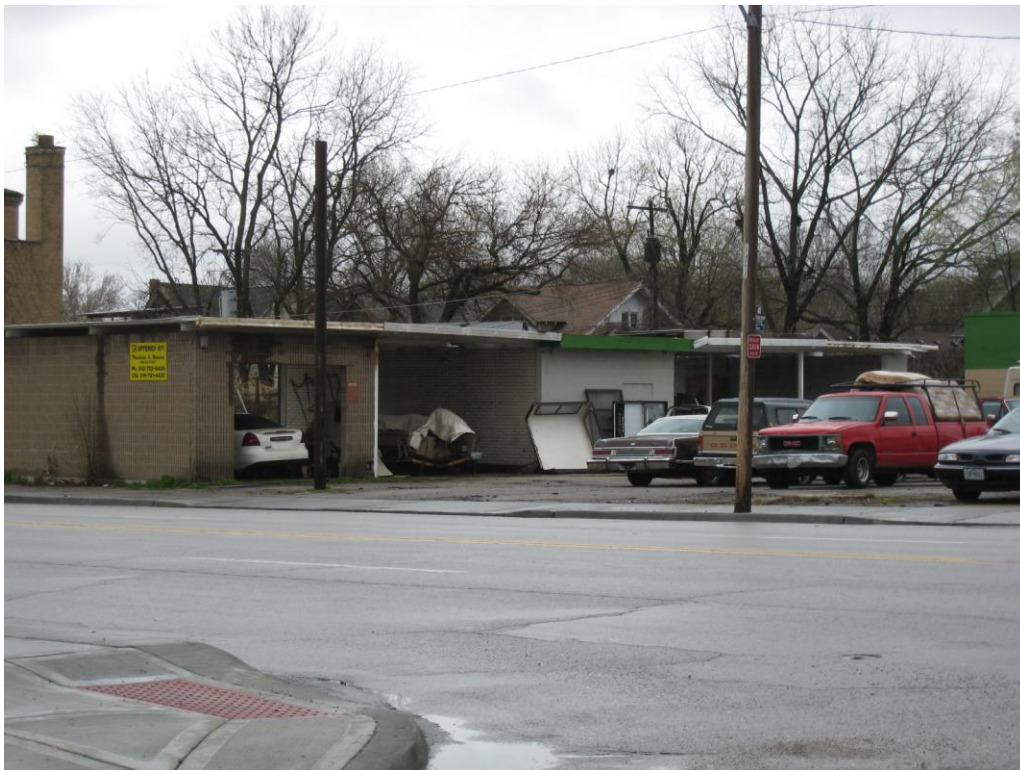
Poor building and site conditions, reuse of former carwash at 4504 Troost Avenue  
*(Deteriorated or inadequate site improvements)*

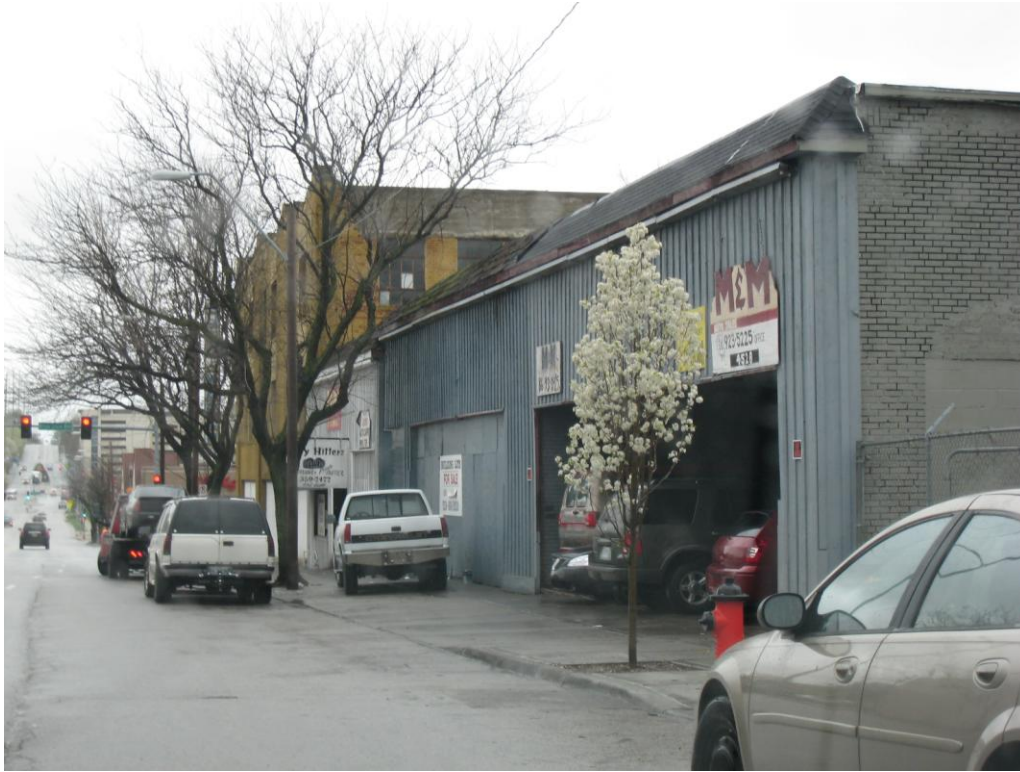
Former retail space reused as auto servicing at 4524 and 4528 Troost Avenue  
*(Deteriorated or inadequate site improvements, Economic and social liability)*

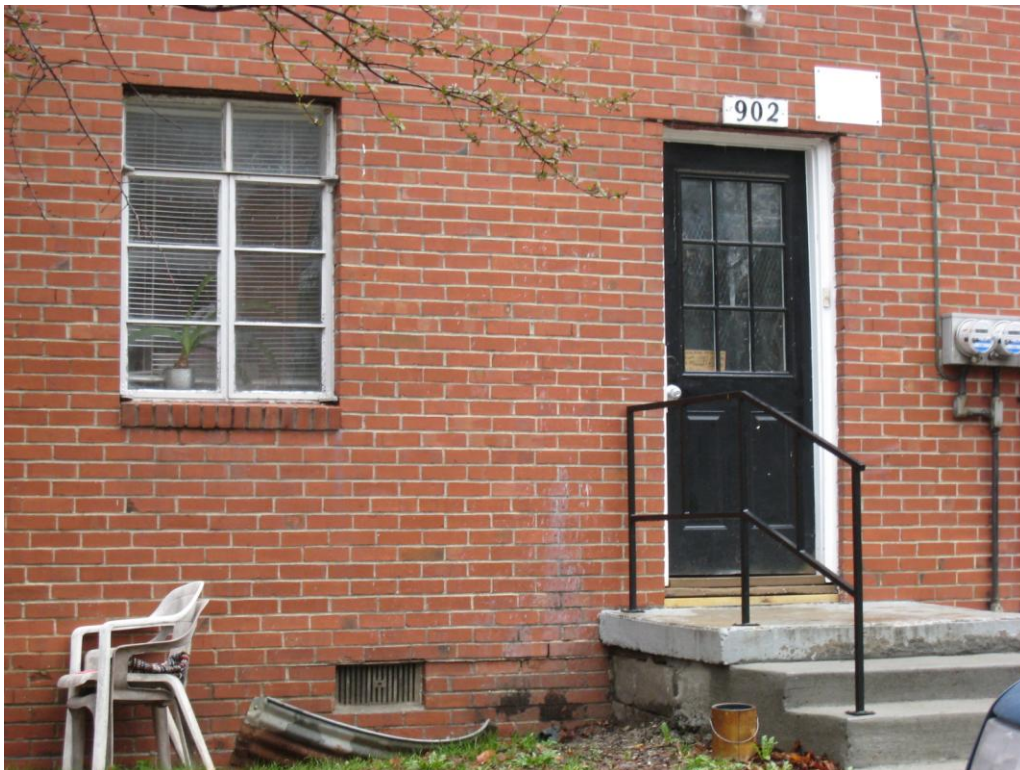
Indications of poor maintenance at rear of property at 902 Emanuel Cleaver II  
*(Deteriorated or inadequate site improvements, Menace to public health, safety)*

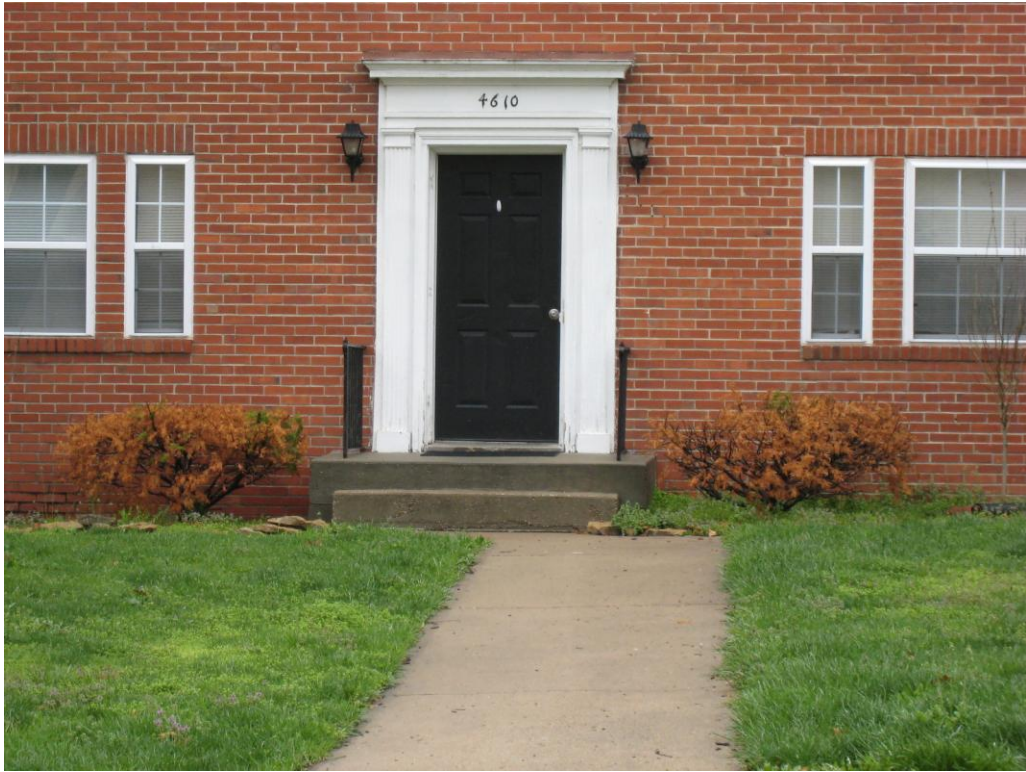
Lack of accessible route and primary building entry at 4610 Campbell Street  
*(Unsanitary and unsafe conditions)*

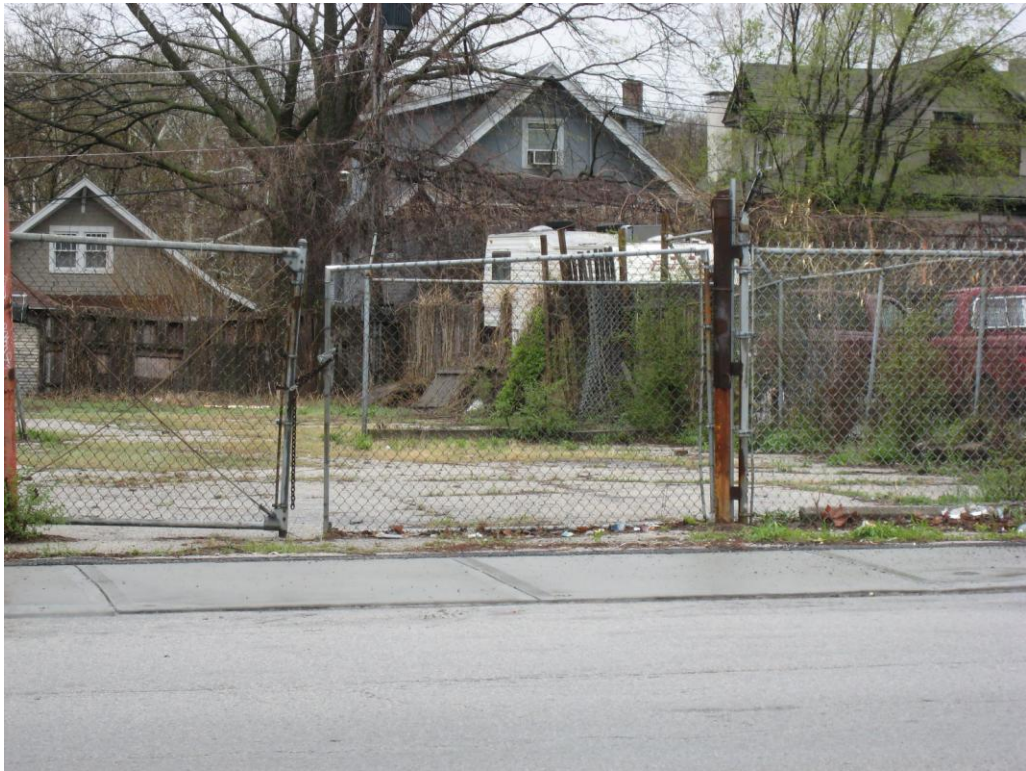
Deteriorated fencing and site conditions of vacant parcel at 4512B Troost Avenue  
*(Deteriorated or inadequate site improvements, Economic and social liability)*

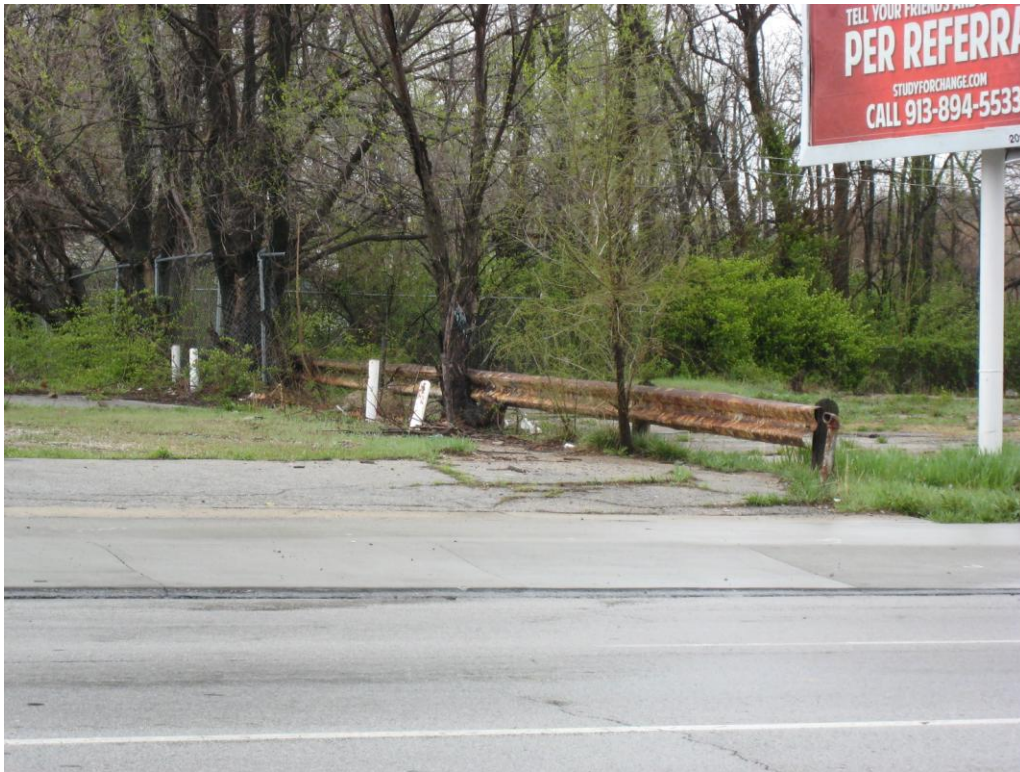
Deteriorated site conditions at southwest corner of property at 4601 Troost Avenue  
*(Deteriorated or inadequate site improvements)*

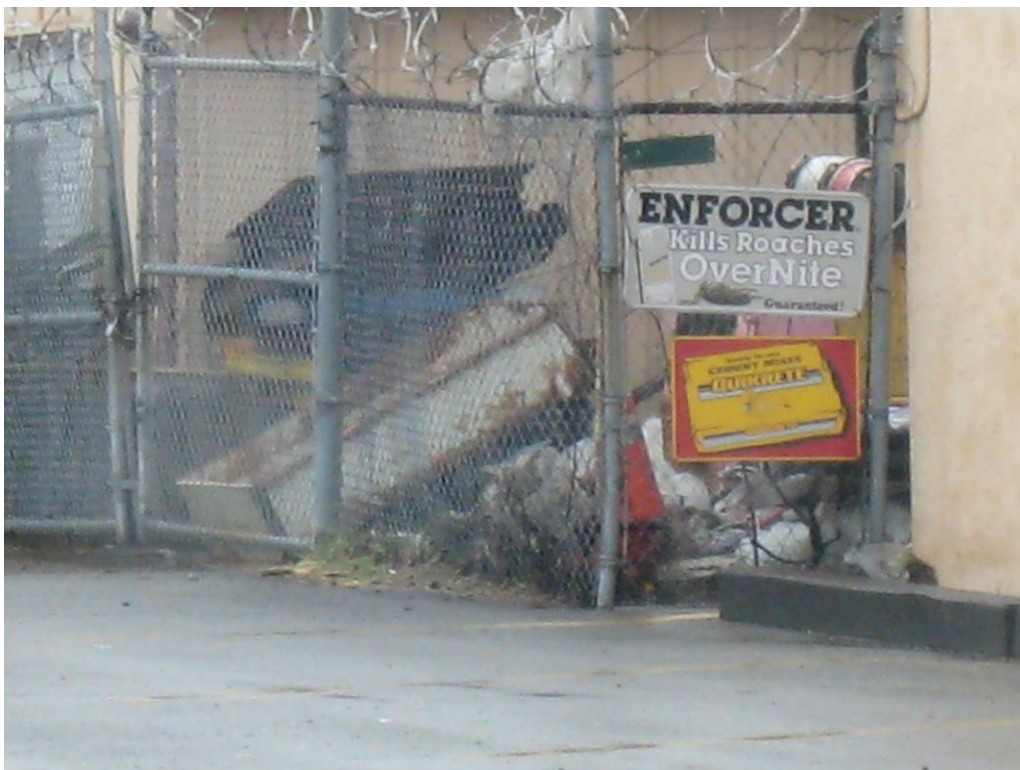
Poor site conditions at northeast corner of property at 4627 Troost Avenue  
*(Unsanitary or unsafe conditions, Deteriorated or inadequate site improvements)*

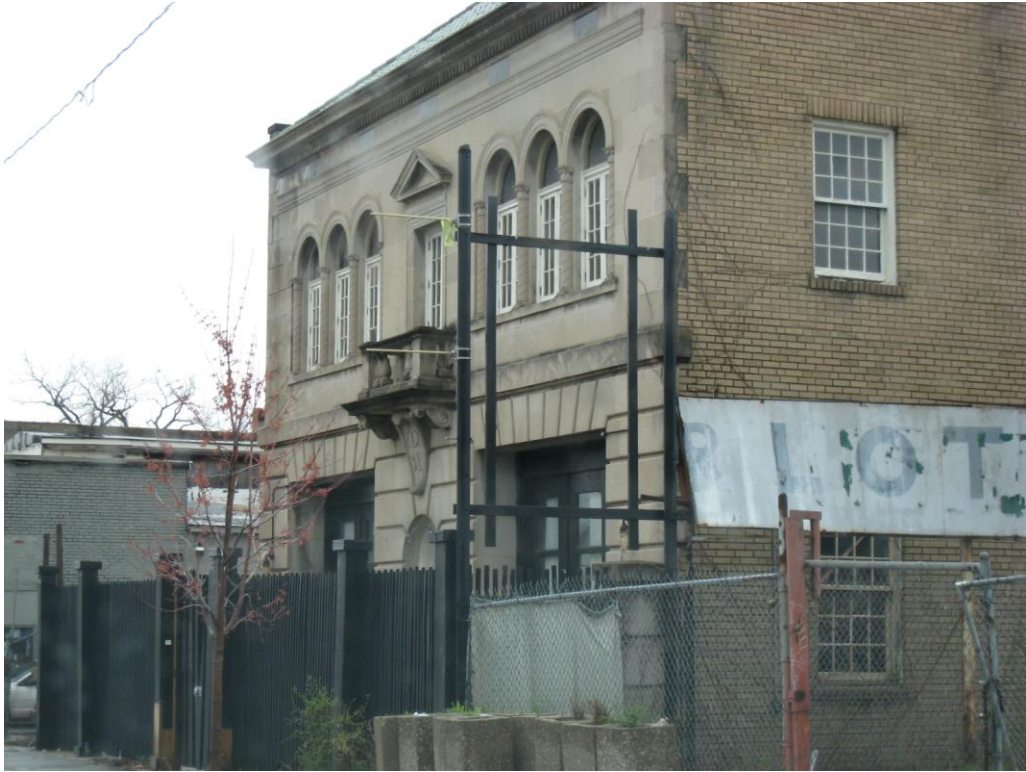
Deteriorated site conditions, vacant historic building at 4518 Troost Avenue  
*(Deteriorated or inadequate site improvements, Economic and social liability)*

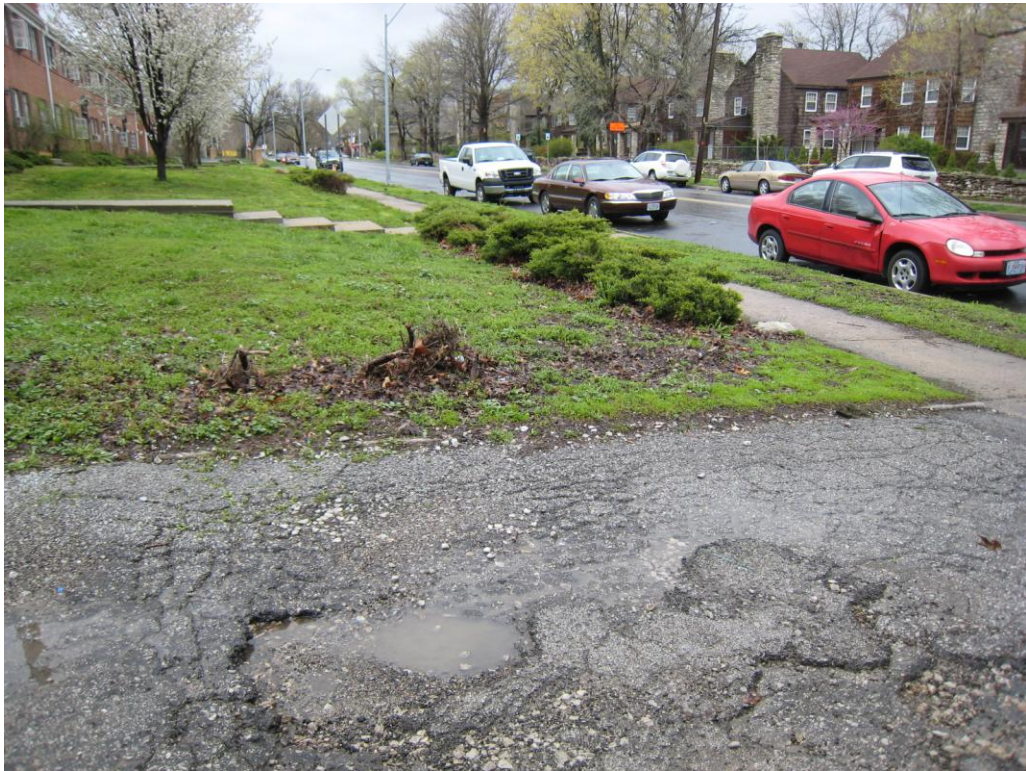
Deteriorated site conditions southeast corner of property at 4616 Harrison  
*(Deteriorated or inadequate site improvements)*

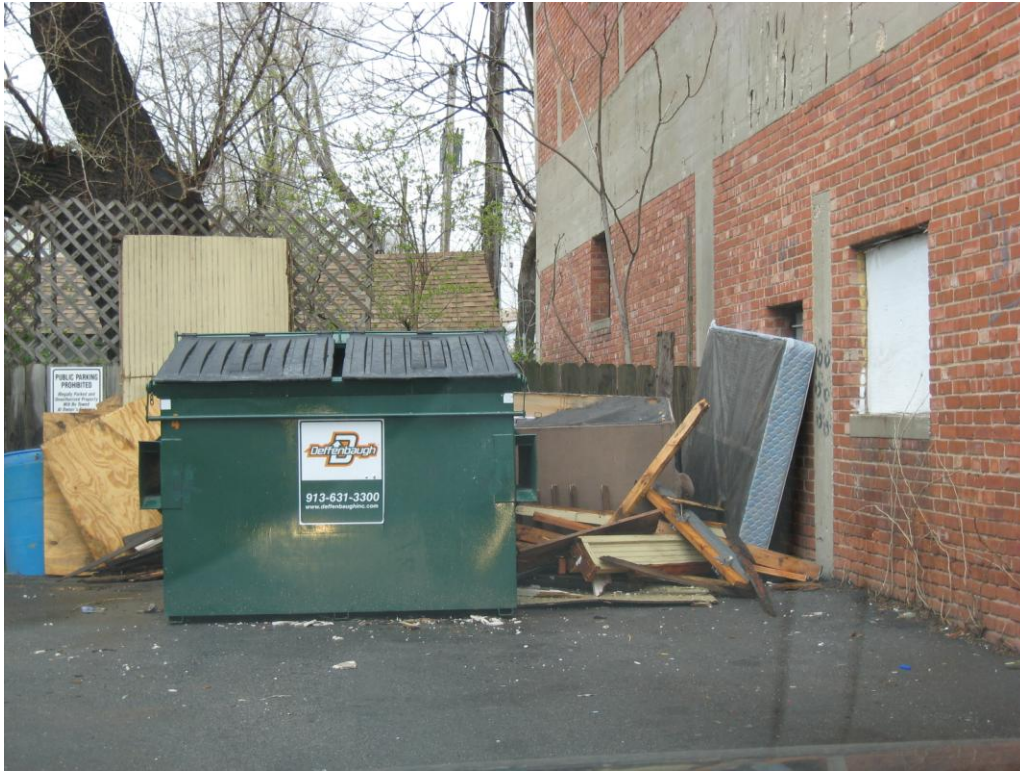
Unscreened trash disposal and debris on west side of 4538 Troost Avenue  
(*Unsanitary or unsafe conditions, Conditions which endanger life or property*)

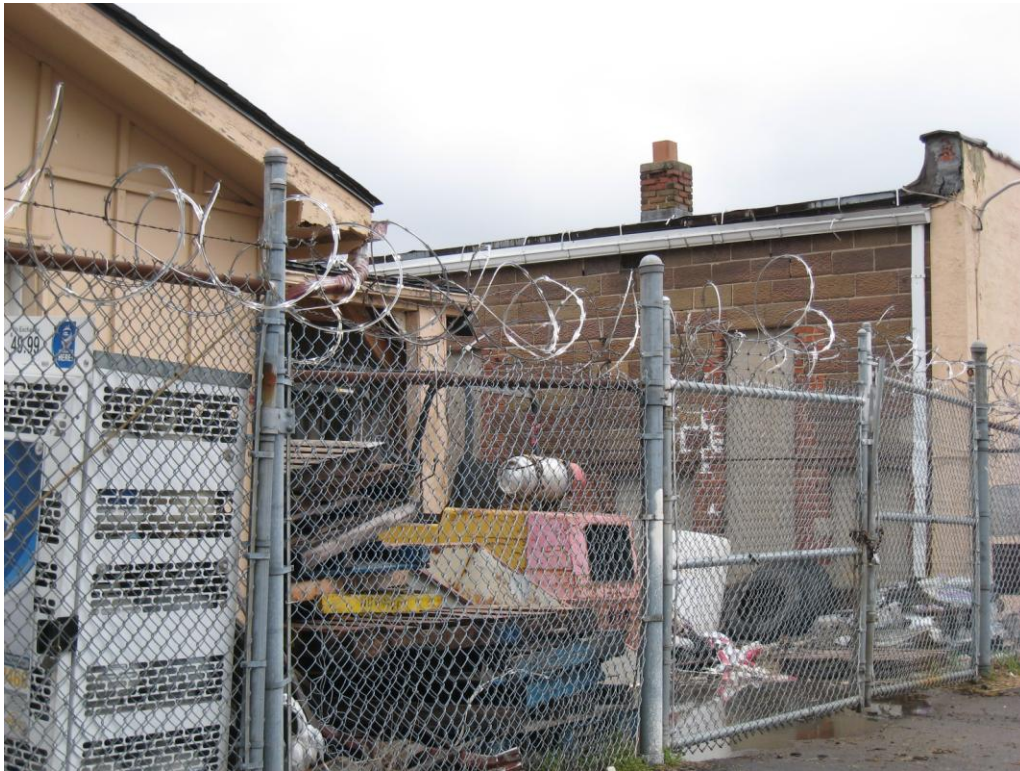
Accumulated debris and unsightly fencing rear of property at 4627 Troost Avenue  
(*Unsanitary or unsafe conditions, Deteriorated or inadequate site improvements*)

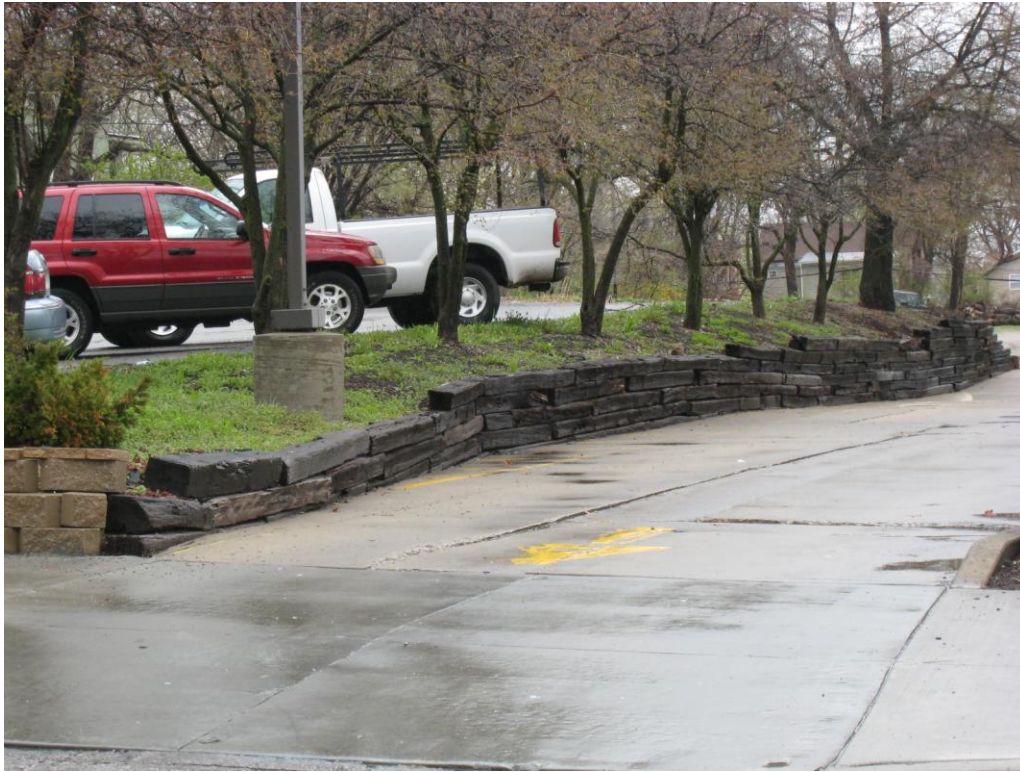
Deteriorated retaining wall and landscaping on north side of 1102 East 47th Street  
*(Deteriorated or inadequate site improvements)*

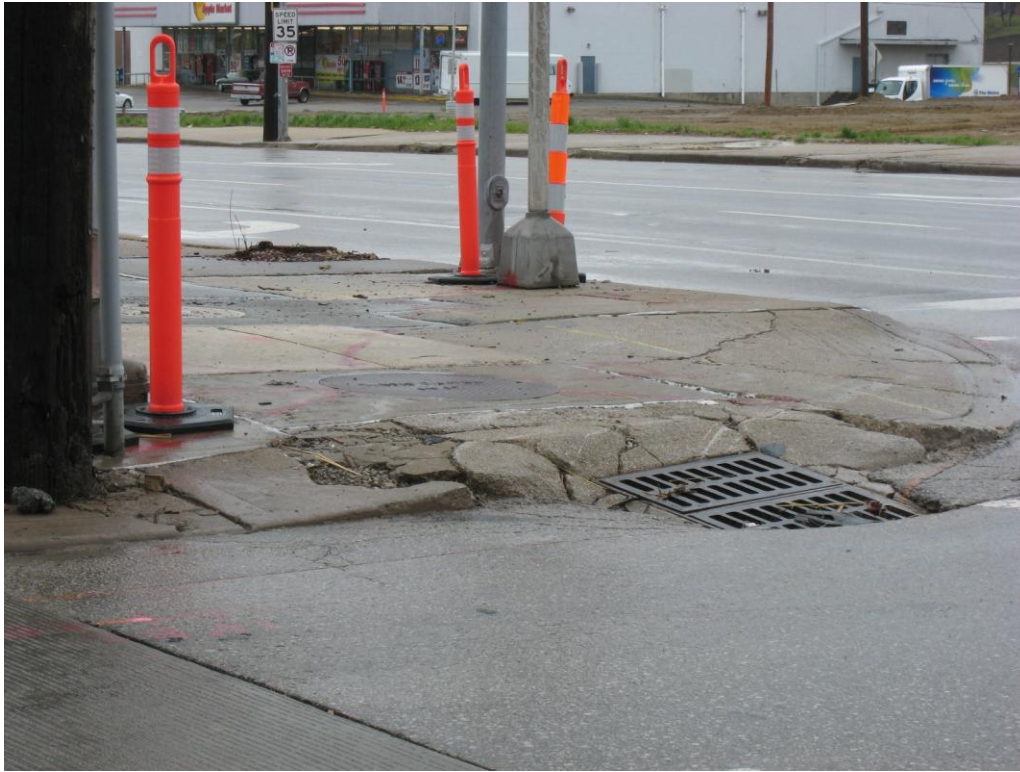
Storm water inlet at northeast corner of Troost Avenue and Emanuel Cleaver II  
*(Deteriorated or inadequate site improvements)*

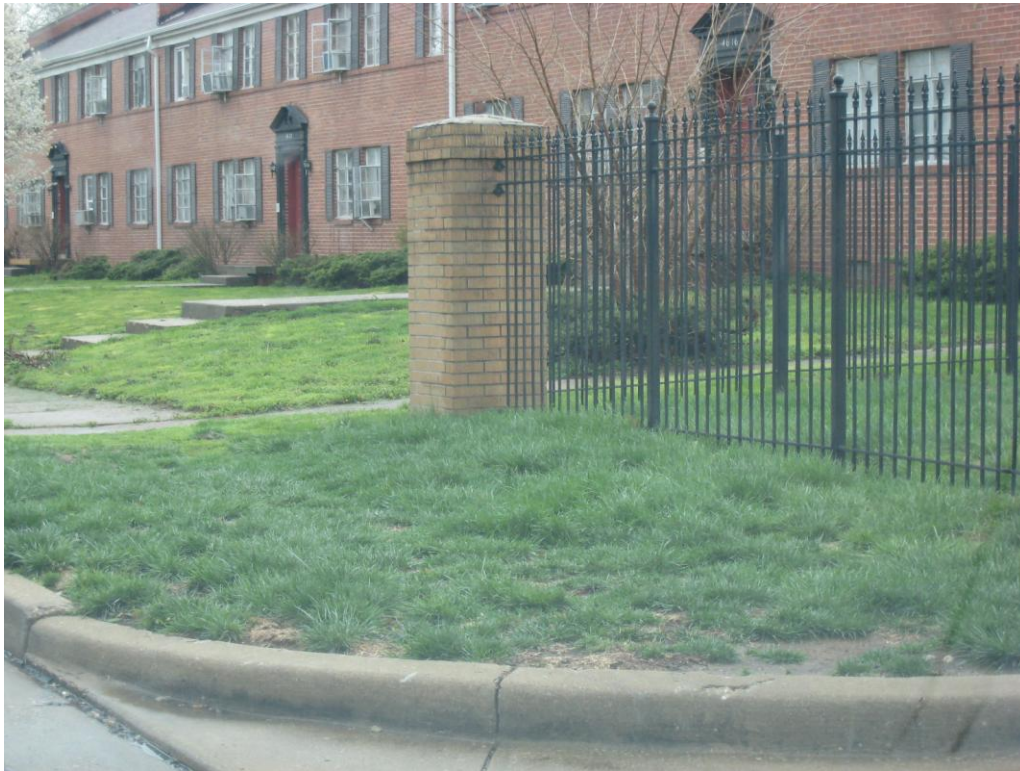
Lack of accessible public sidewalk, curb ramp east side 901 Brush Creek Boulevard  
*(Deteriorated or inadequate site improvements)*

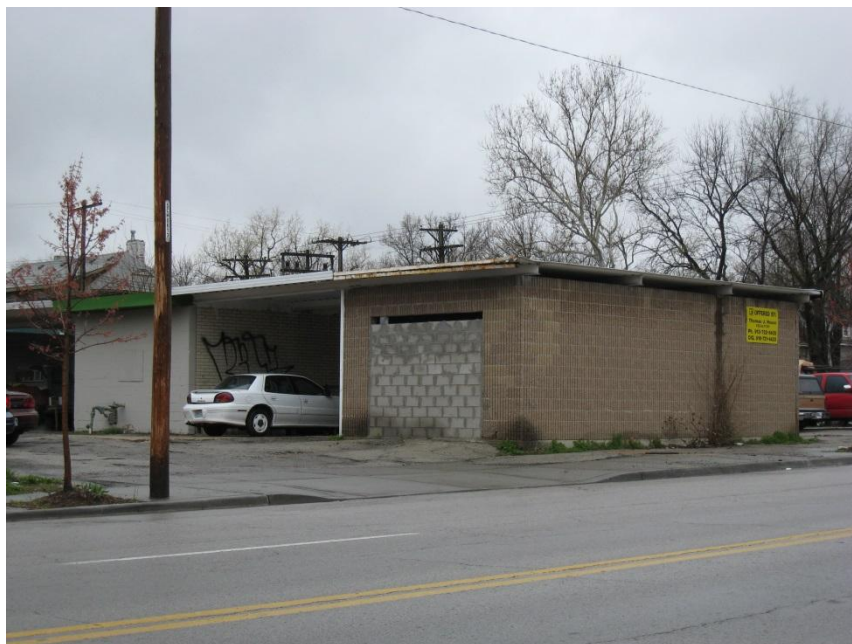
Fencing	Poor
Landscaping	N/A
Private Sidewalk	N/A
Driveway	Good
Parking Area	Poor
Public Sidewalk	Good/Troost, Poor 45 <sup>th</sup> Street
Other

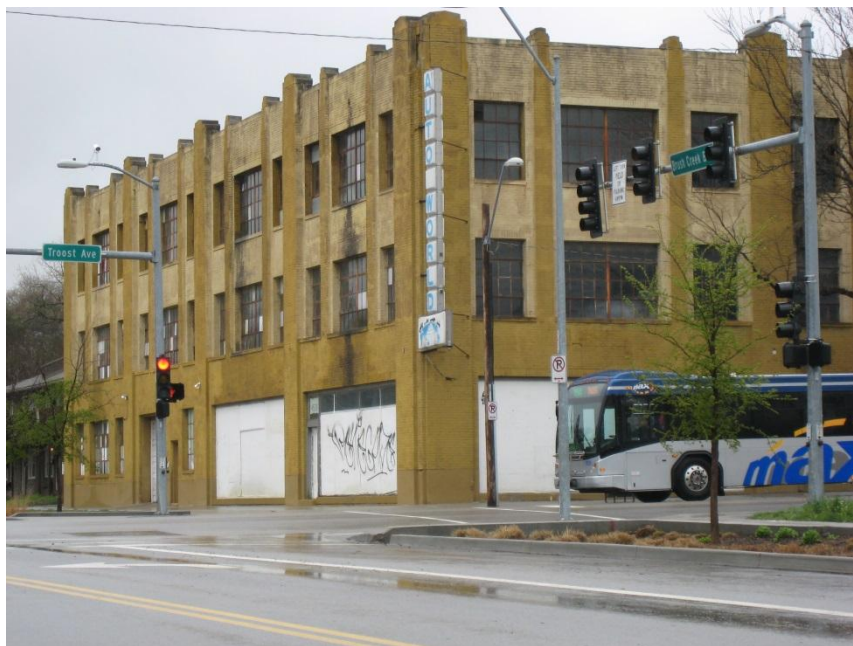
Fencing	N/A
Landscaping	N/A
Private Sidewalk	N/A
Driveway	Good
Parking Area	N/A – no off-street parking provided
Public Sidewalk	Good
Other	Graffiti, unscreened dumpster, dumping, deteriorated signage

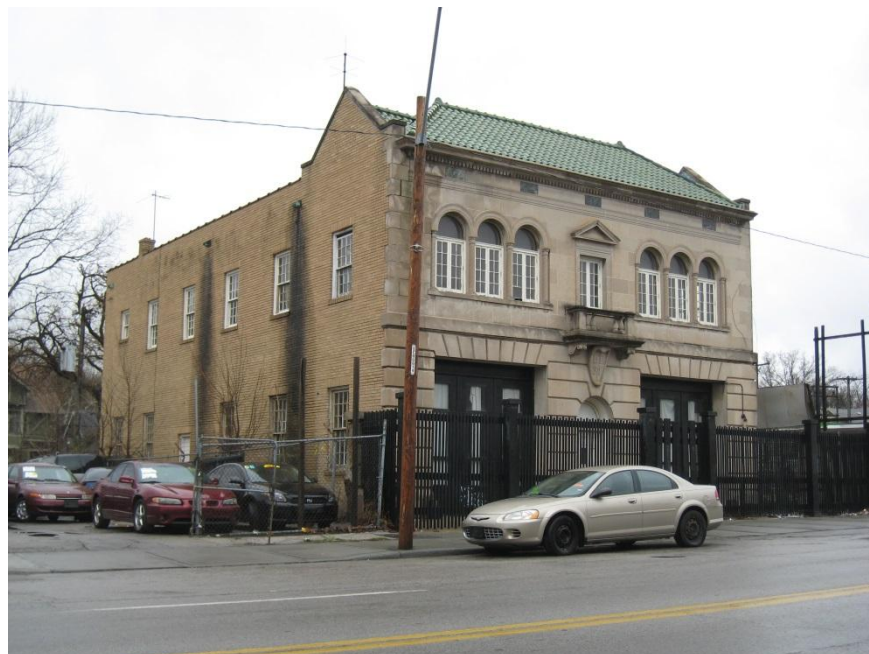
Fencing	Fair
Landscaping	N/A
Private Sidewalk	Fair
Driveway	N/A
Parking Area	N/A – no off-street parking provided
Public Sidewalk	Good
Other	Graffiti, deteriorated signage on north side of building

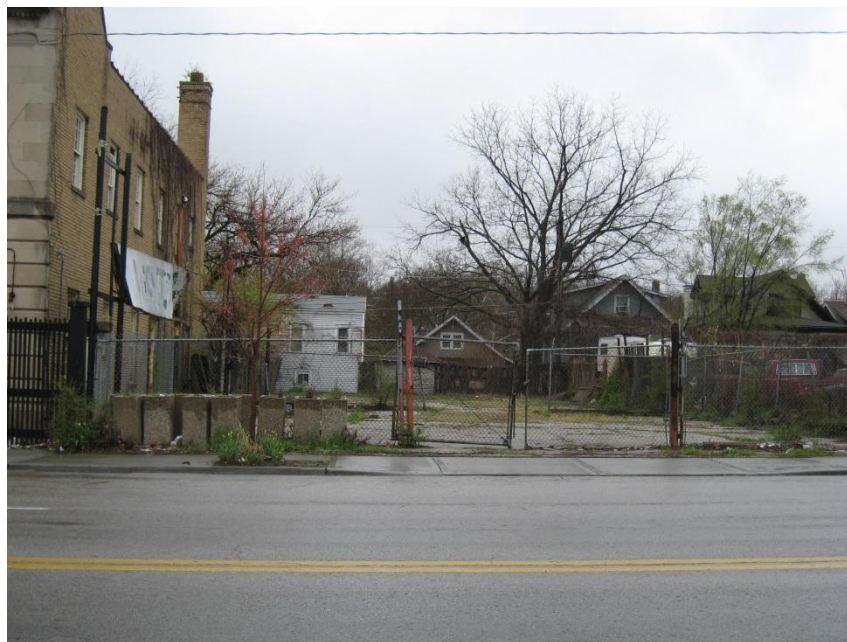
Fencing	Poor – cyclone fencing
Landscaping	N/A
Private Sidewalk	N/A
Driveway	Good
Parking Area	Poor
Public Sidewalk	Good
Other	Accumulated trash and debris

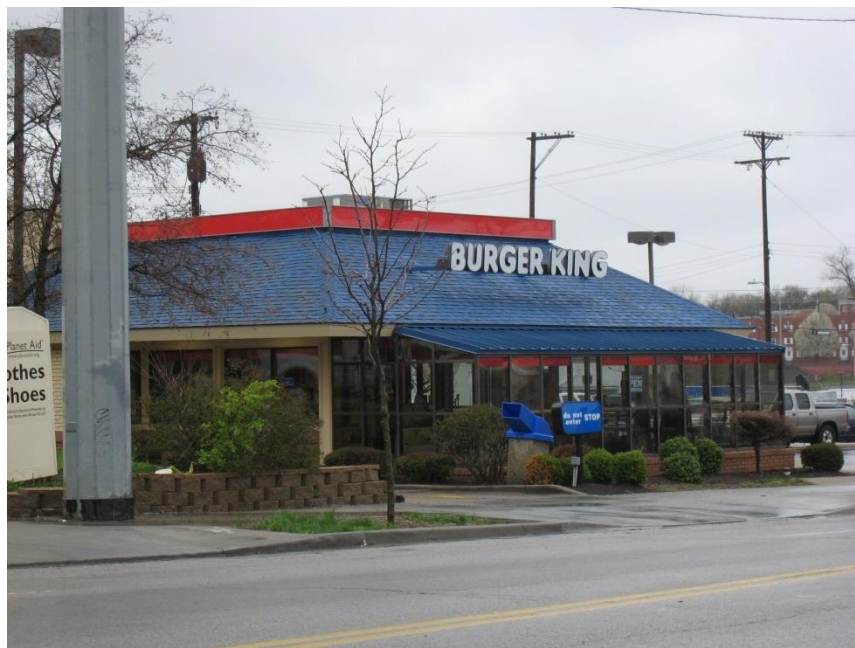
Fencing	Fair
Landscaping	Fair
Private Sidewalk	Good
Driveway	Good
Parking Area	Fair
Public Sidewalk	Good/Troost , Fair/Emanuel Cleaver II
Other	Deteriorated retaining wall

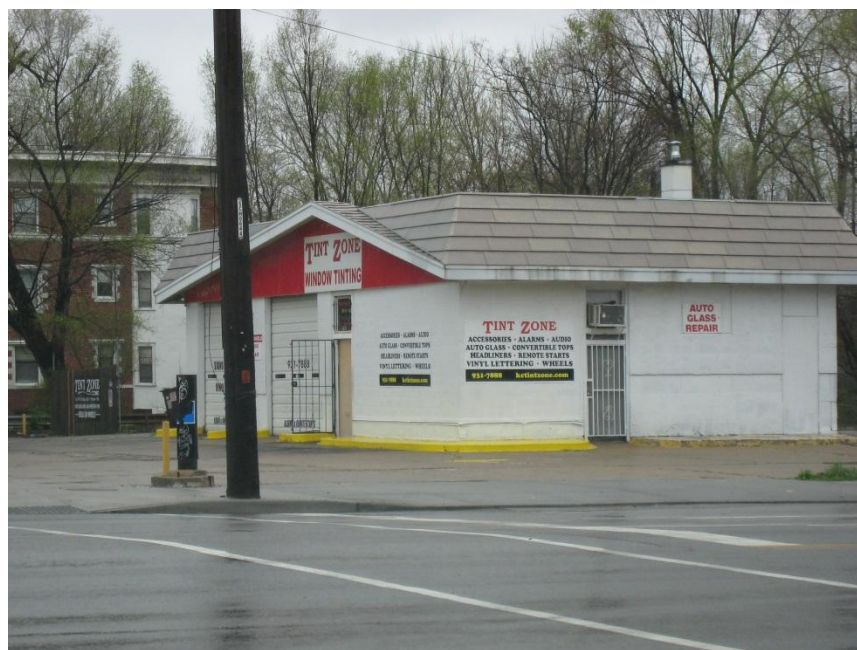
Fencing	Poor
Landscaping	Poor
Private Sidewalk	N/A
Driveway	Good
Parking Area	Poor
Public Sidewalk	Good
Other	Potentially contaminated site, poor signage, billboard on parcel

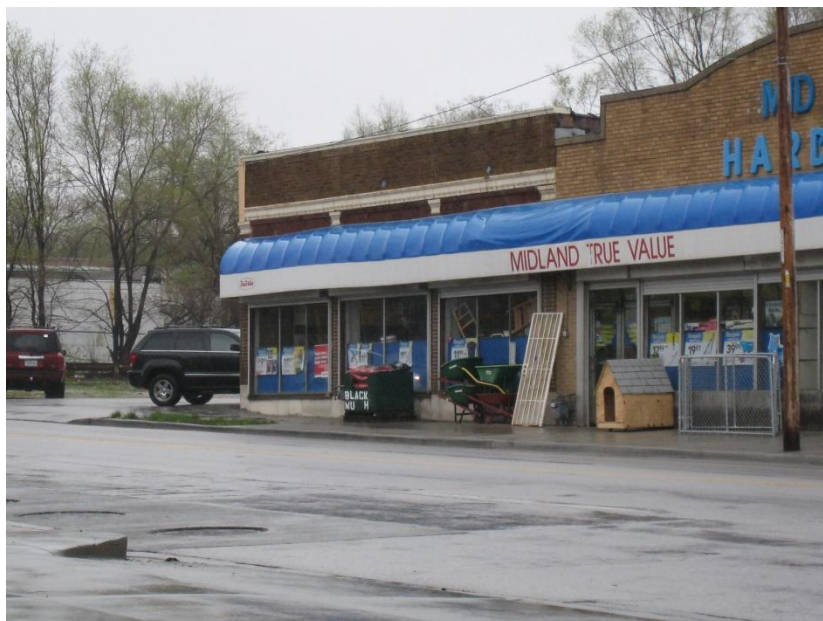
Fencing	Poor
Landscaping	N/A
Private Sidewalk	N/A
Driveway	Good
Parking Area	Fair
Public Sidewalk	Good
Other	Outdoor storage, deteriorated signage on north side of building
