BEST PRACTICES *for* STORMWATER MANAGEMENT IN METROPOLITAN KANSAS CITY

RAIN GARDEN | PERVIOUS SURFACE

Leo G. Koehler Roof Rain Garden, 34900 E. US 40 Hwy, Grain Valley, Missouri

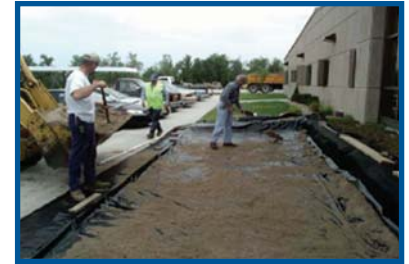
Construction of the roof drained rain garden.

Native stone was used to build the 1,000 square foot rain garden that was planted with water tolerant native wildflowers and grasses. The roof of the building drains directly into the rain garden, with excess water flowing into the adjacent wetland. Also included in this project is a 380 square foot area surrounding the building's three flag poles, that was loosely covered with flagstone and native limestone boulders, then planted with drought resistant native plants.

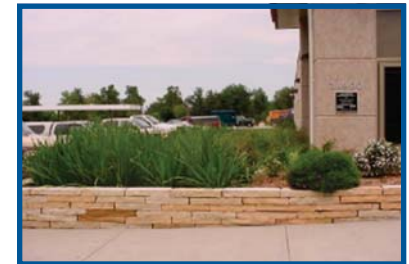
Ornamental planting of natives maintains a landscape aesthetic next to the building.

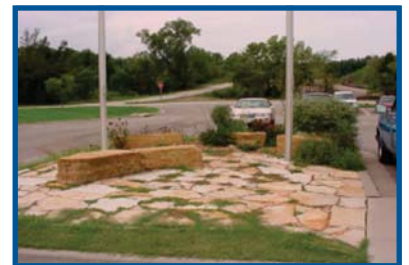
The flagstones provide a more pervious surface to improve infiltration of stormwater.
